WEST INDIA GOODS STORE

Salem Maritime
National Historic Site

Historic Structure Report

HISTORIC STRUCTURE REPORT Architectural Data

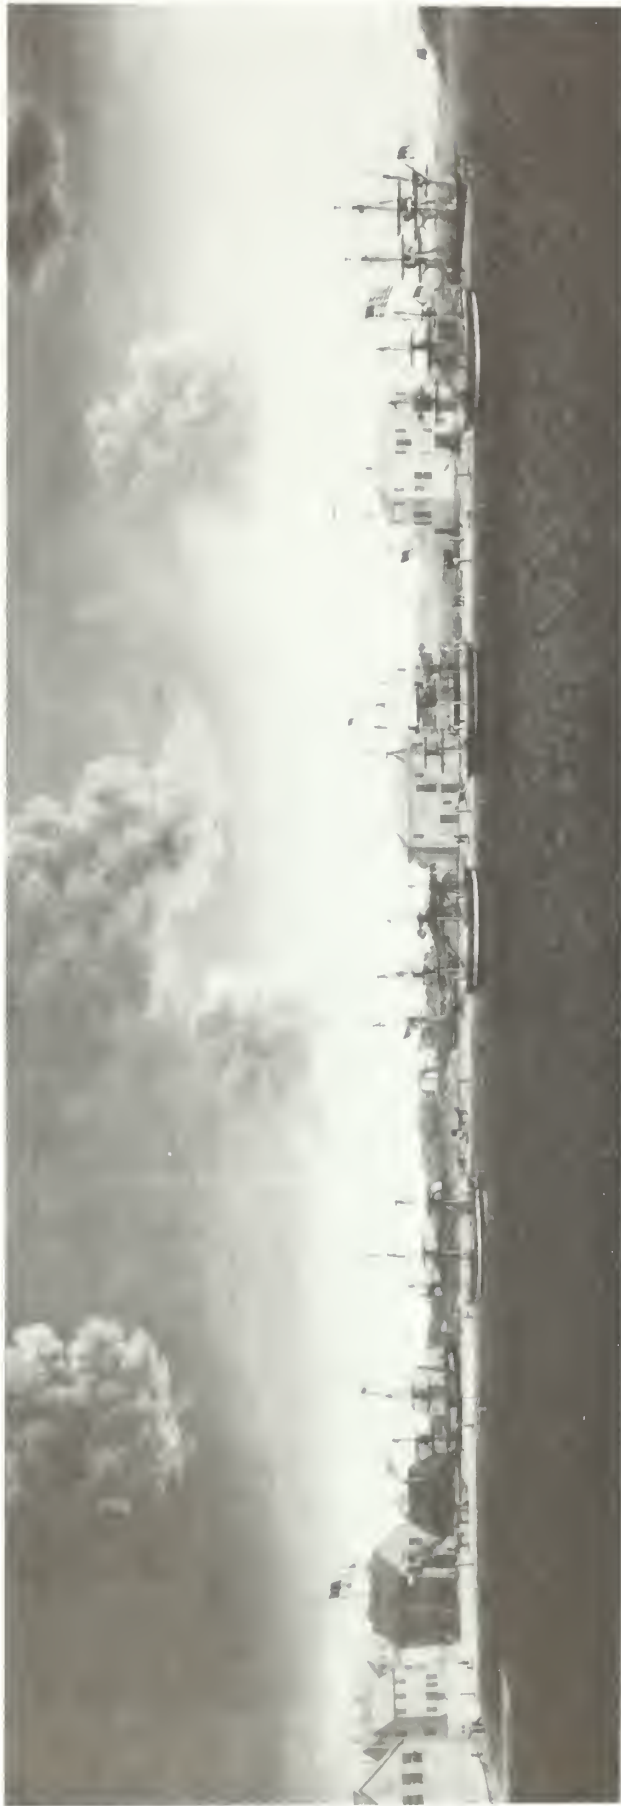
All structures shown in historic views are sided with clapboards, with one exception. In the 1806 view of Crowninshield Wharf (fig. 1), the hipped-roof structure on the far right is sided with flush boards in panels, with the major vertical structural members and the floor marked by boards on the exterior. All structures shown in historic views have corner boards; none are shown with skirt boards.

Figure 1. Crowninshield Wharf, looking east, 1806.

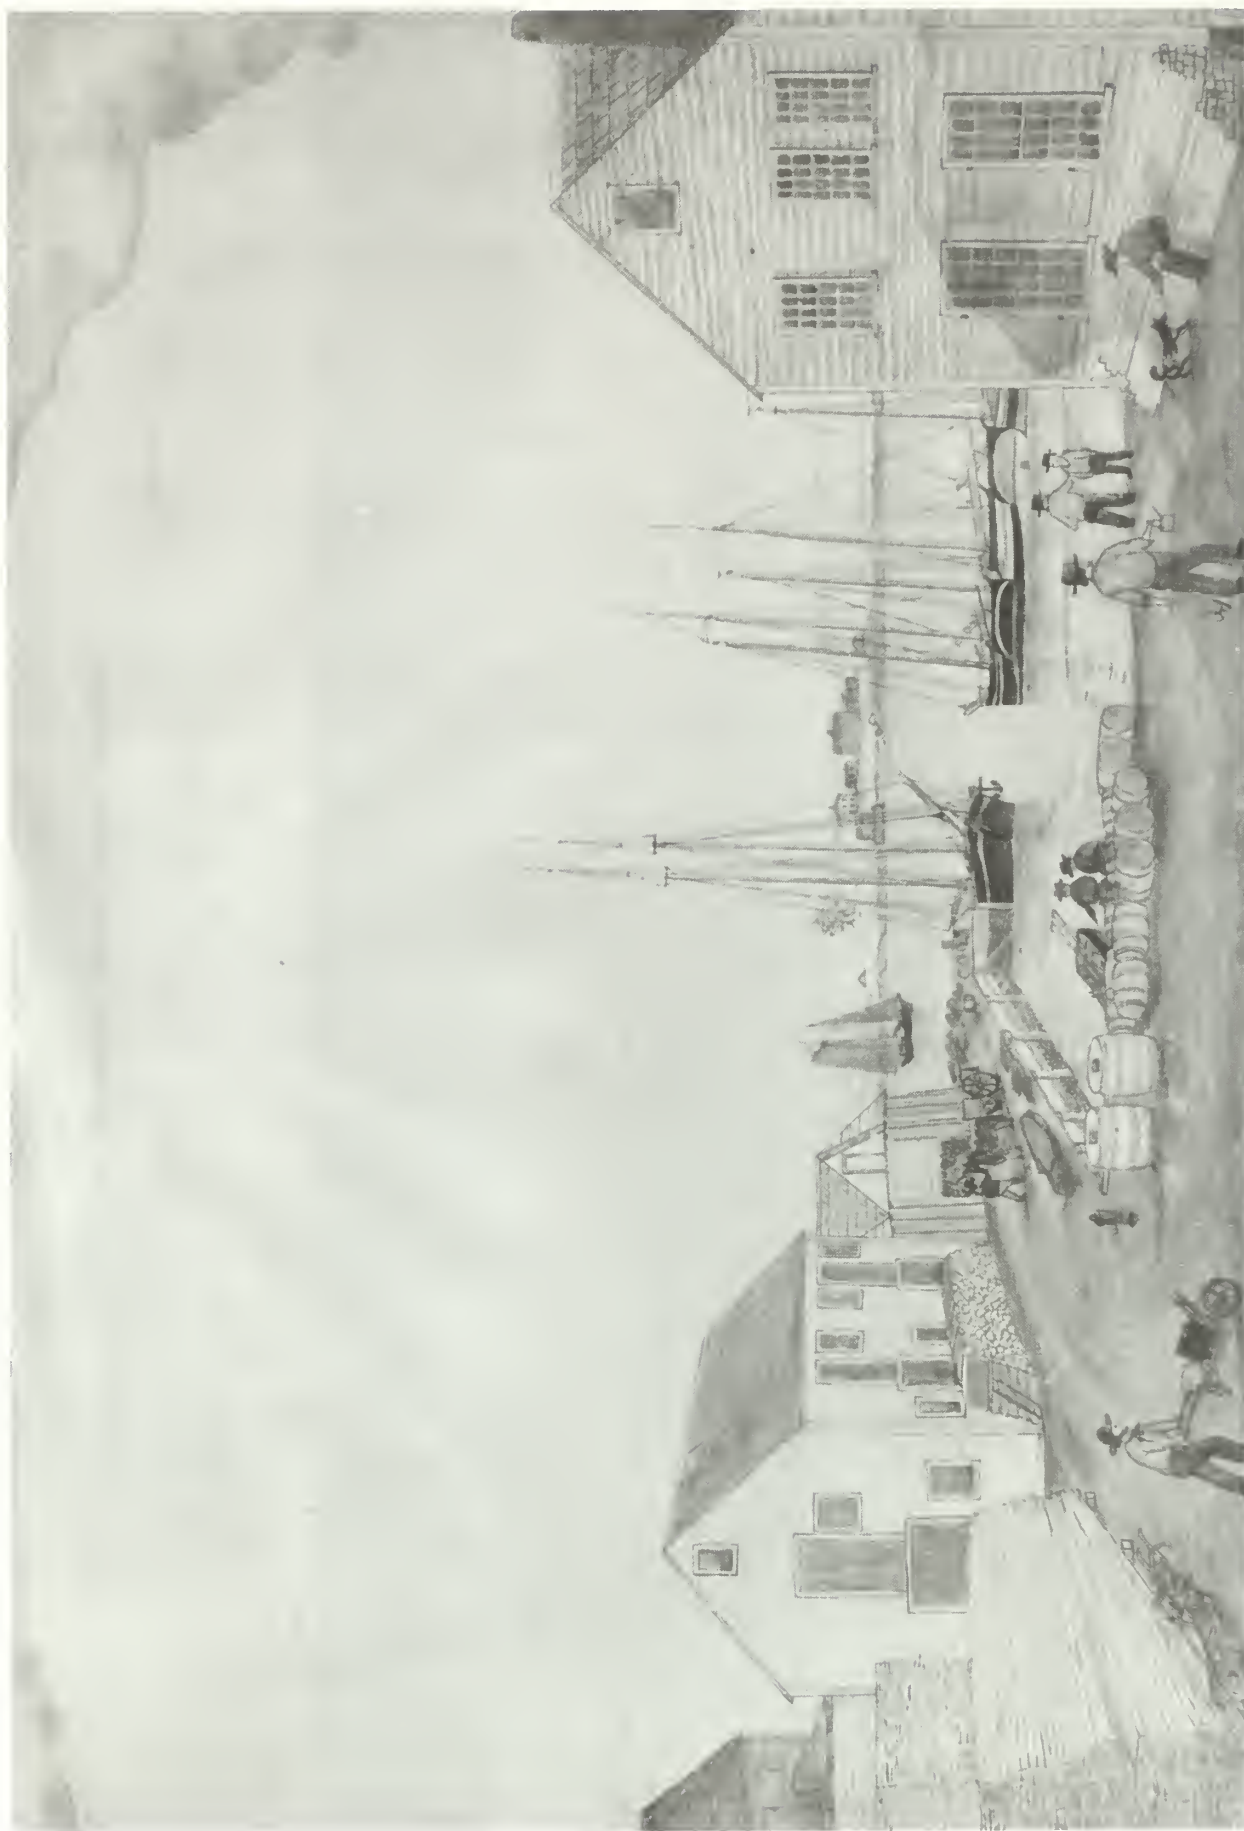
stories; these are fitted with solid board shutters. The ca.- 1850 view of Appleton Wharf (fig. 2) shows distinct window details only for the structure at the left of the view. For the gable-end elevation shown, there are two 12-over-12-light sash in the first story, three 8-over-12-light sash in the second story, and a loft space opening in the gable with a solid board cover. The first-story openings have solid board shutters shown open to the left, with two rails and pintle hinges.

The ca.-1850 view of Appleton Wharf (fig. 2) shows two details for window surrounds. The structure on the left, with a mix of opening types with and without sash, has all flat board surrounds with no sills. Three openings in the second story are painted with patterns that resemble sash muntins, but the detail is indistinct. The structure on the right has one opening in the gable, perhaps without sash, that has a flat board surround without sill. The three windows in the second story have 8-over-12-light sash with sills but no shutters. The two windows in the first story have double-hung 12-over-12-light sash. Each has a solid board shutter that is open to the left. The strap hinges are attached to the exterior through the interior rails. The windows on the first and second stories have sills. The surrounds do not appear to be molded.

Figure 2. Appleton's Wharf, ca. 1850.

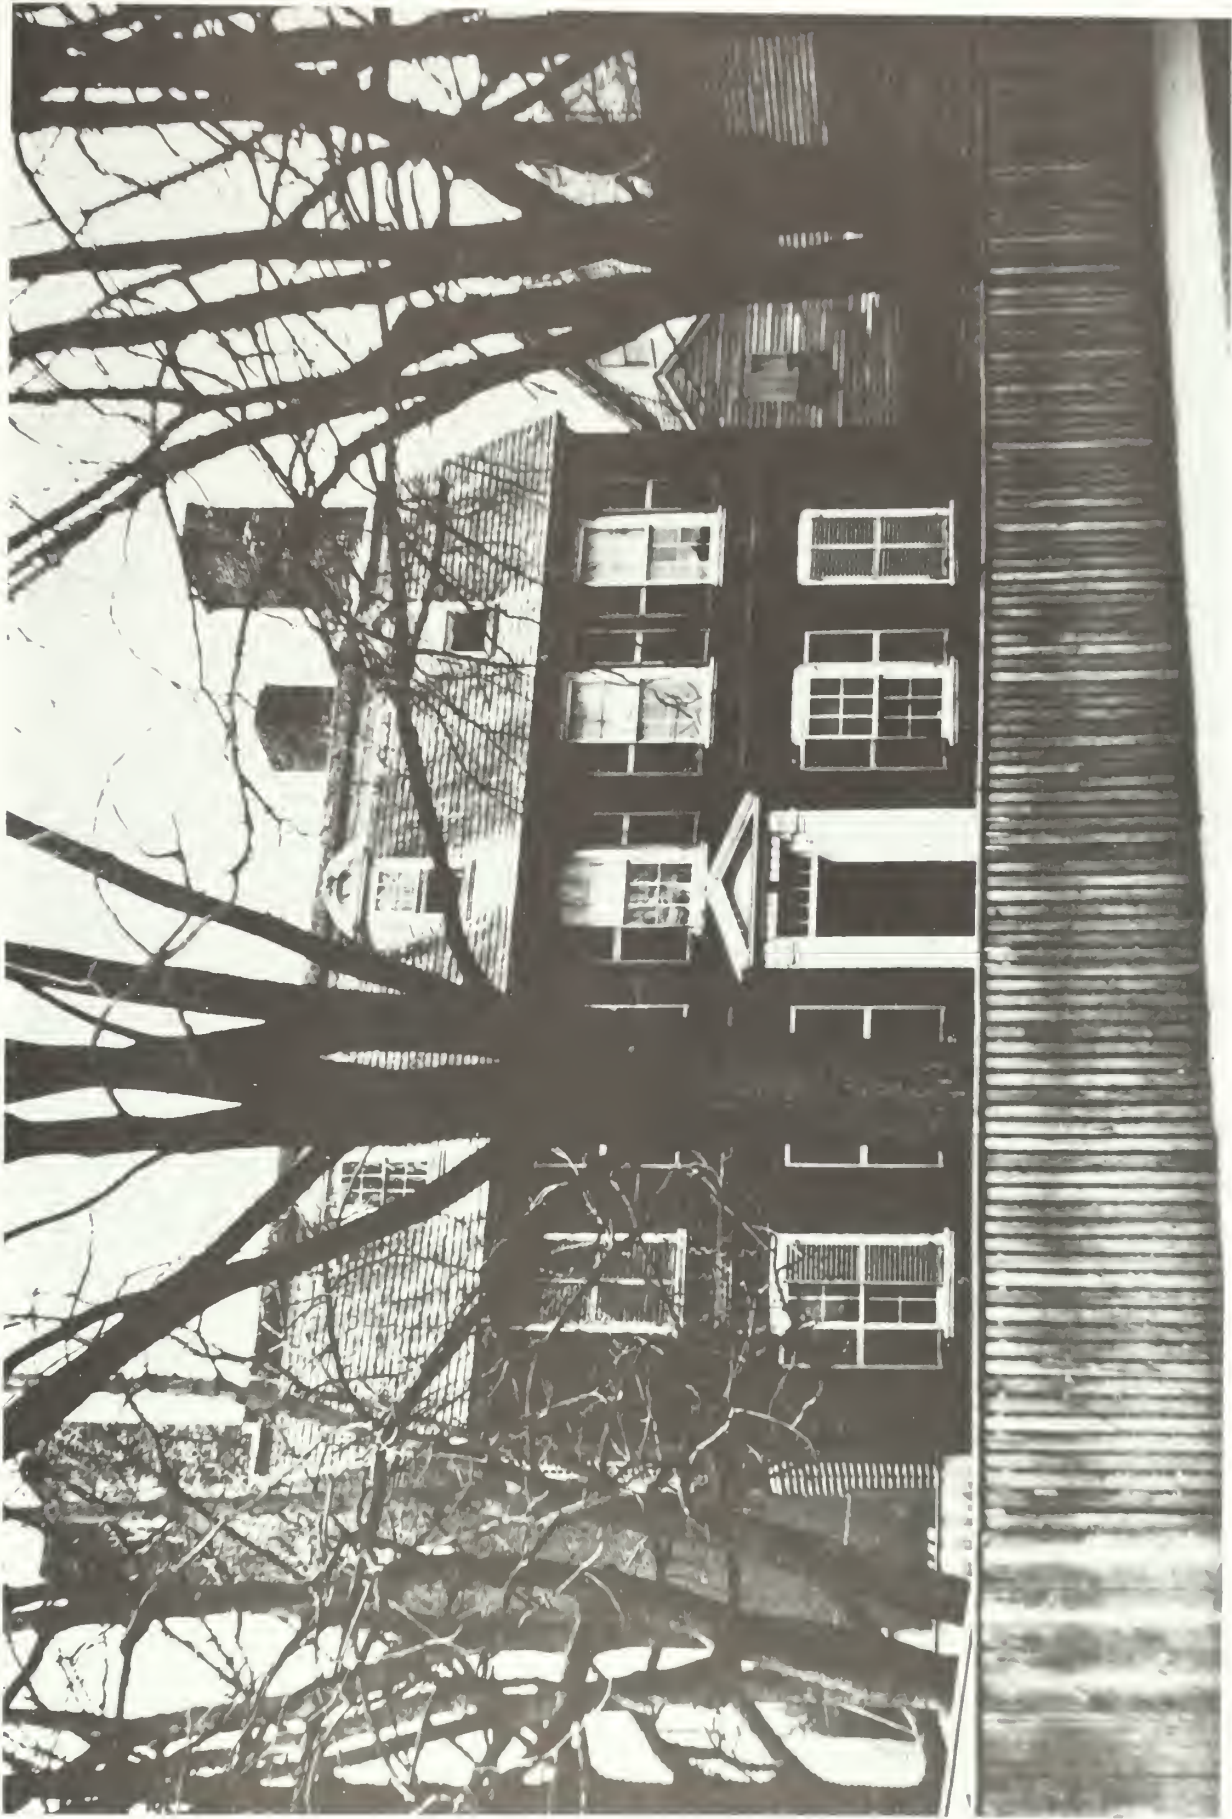
Figure 5. Derby-Prince-Ropes House and West India Goods Store, ca. 1880.

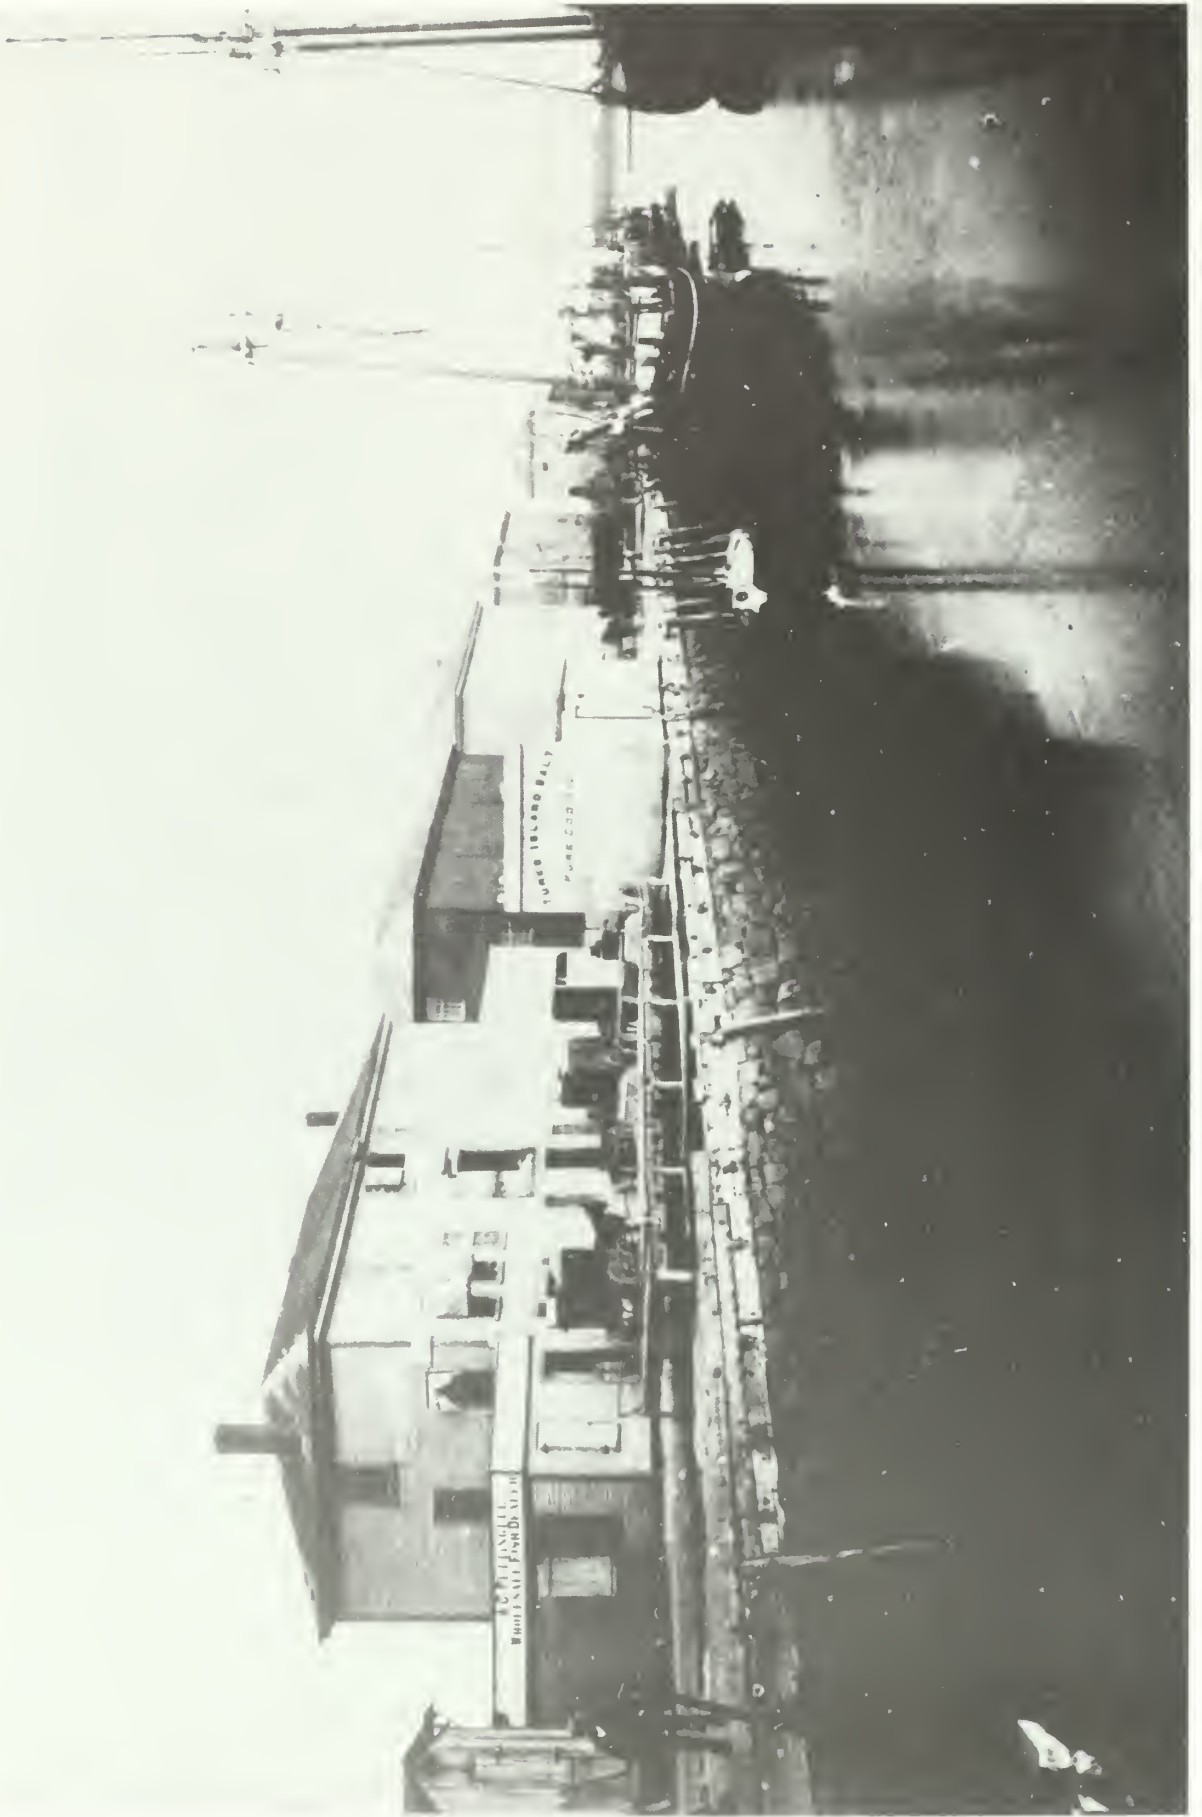
The 1884 photograph of Derby Wharf (fig. 6) shows 'Dutch' doors in the center of the second and third stories of the west elevation of the first hip-roofed structure, left to right. None of the historic views show this door type.

Figure 6. Derby Wharf, looking south from center, 1884.

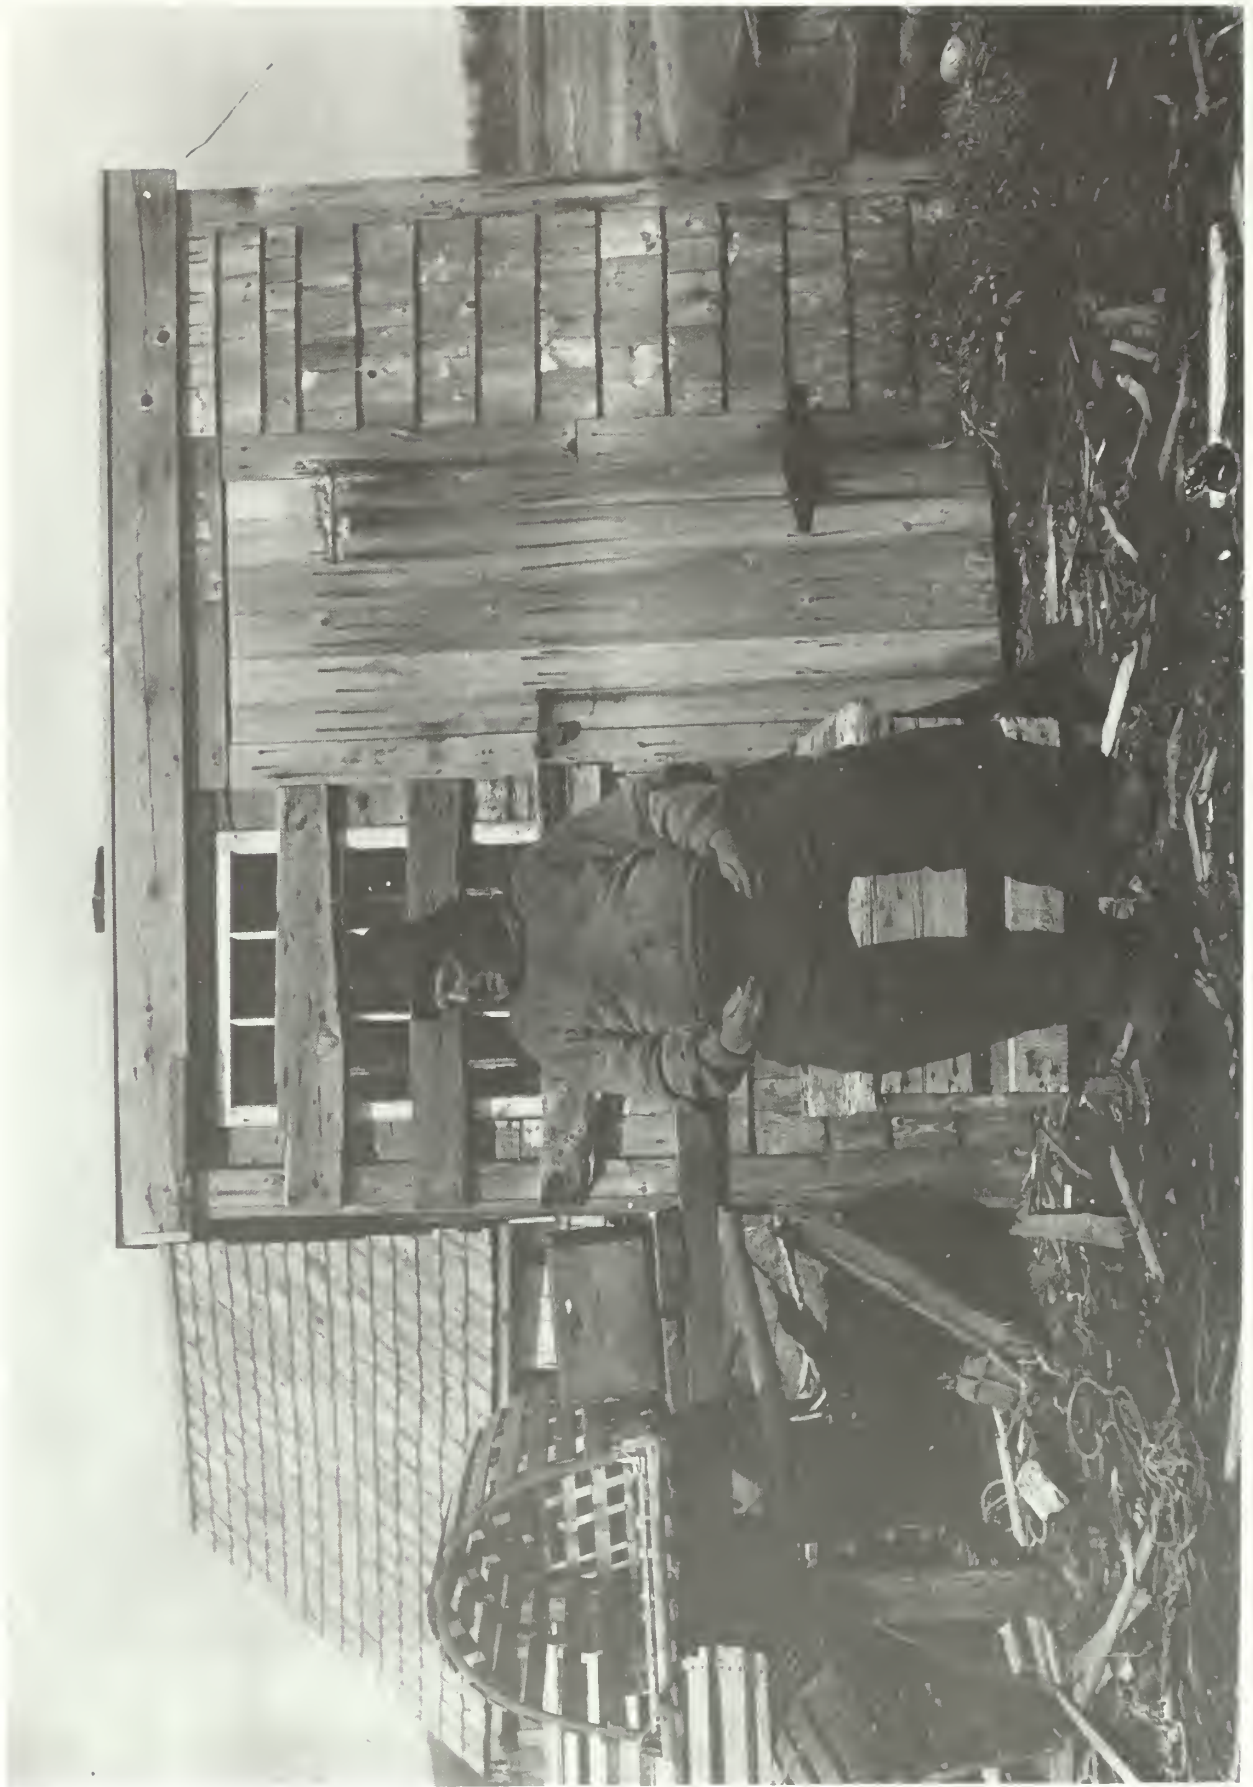
One ca.-1890 photograph of a lobsterman and lobster pots (fig. 9) shows a possible closure for solid shutters. The other ca.-1890 photograph shows how the closure might be used (fig. 8). In this view, the wrought-iron hasp is attached to a small door with a staple and locked through a staple attached to the surround.

Figure 8. Lobster house, man, and pots, northeastern U.S.

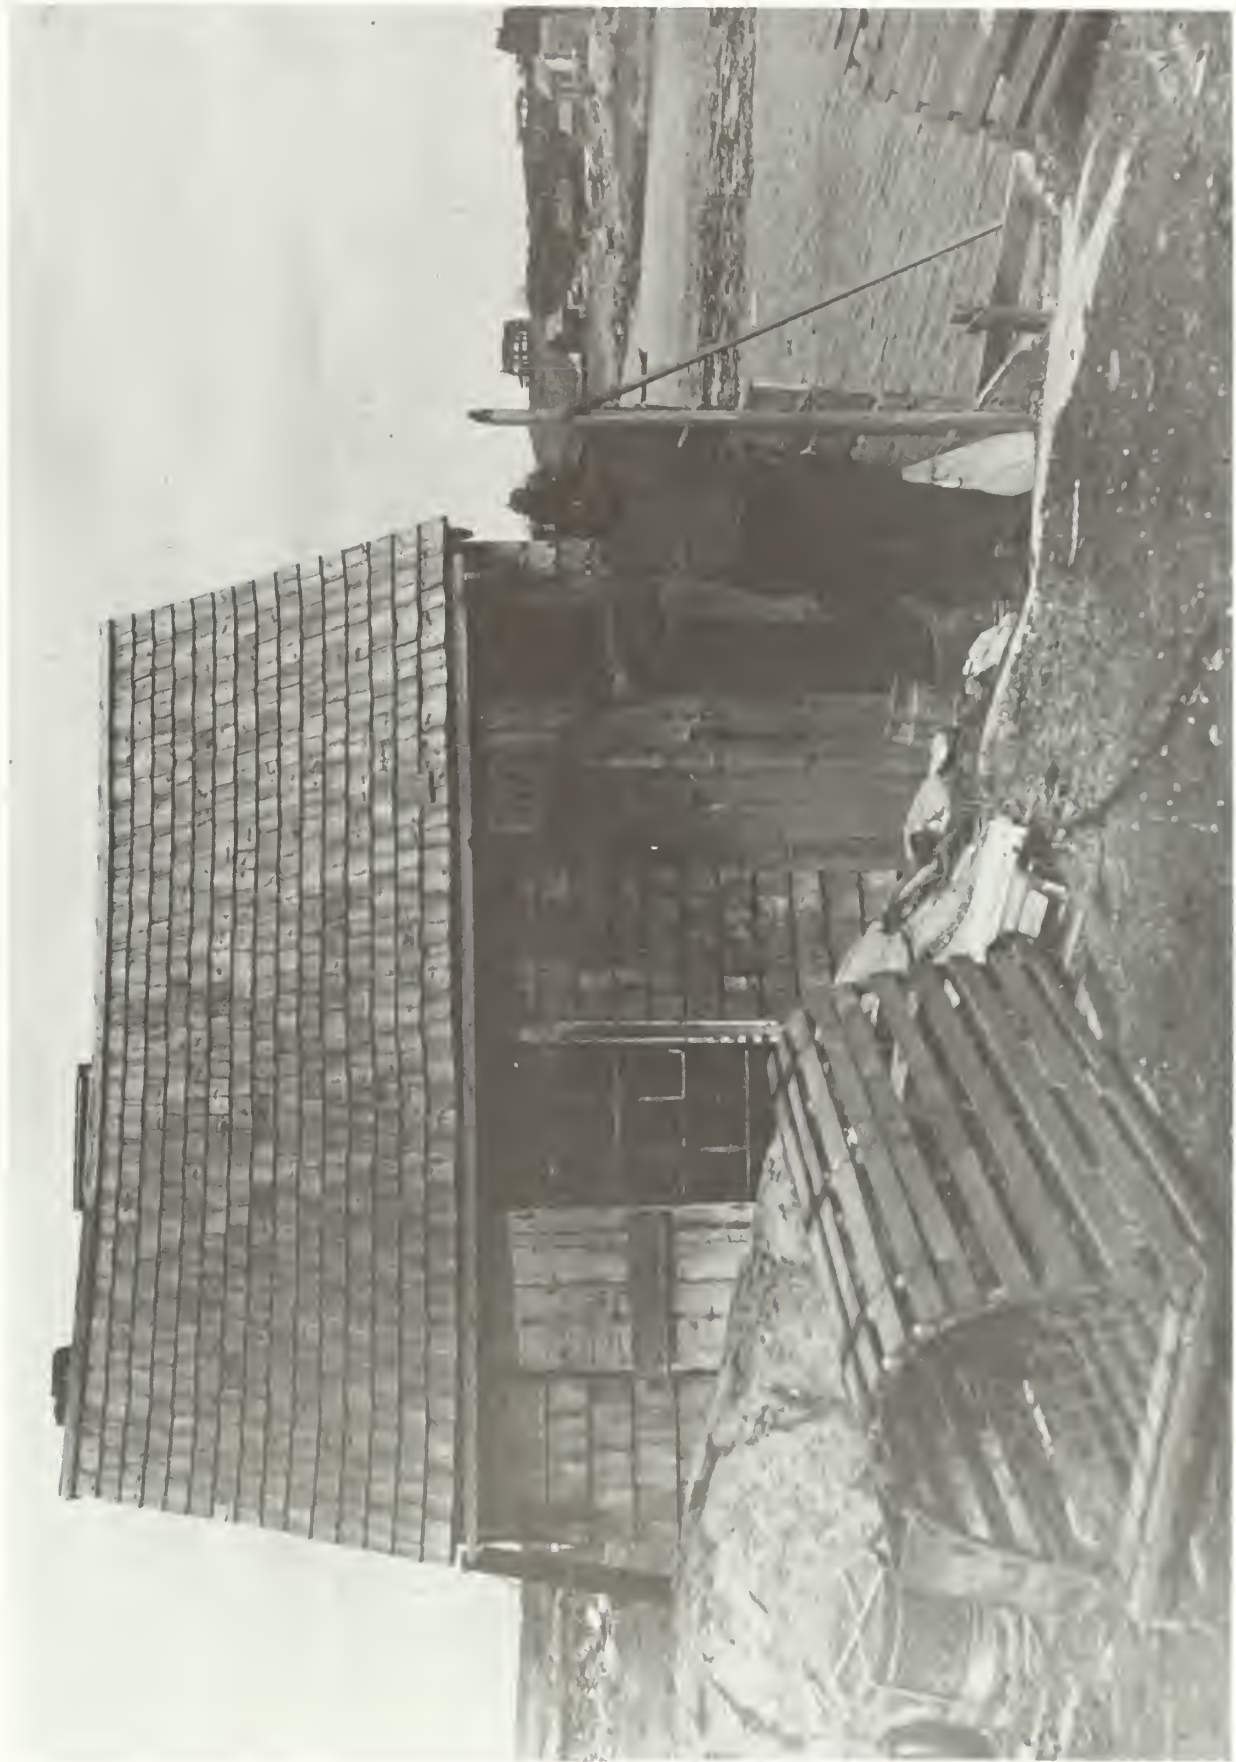
Figure 9. Lobster house, northeastern U.S., ca. 1890.

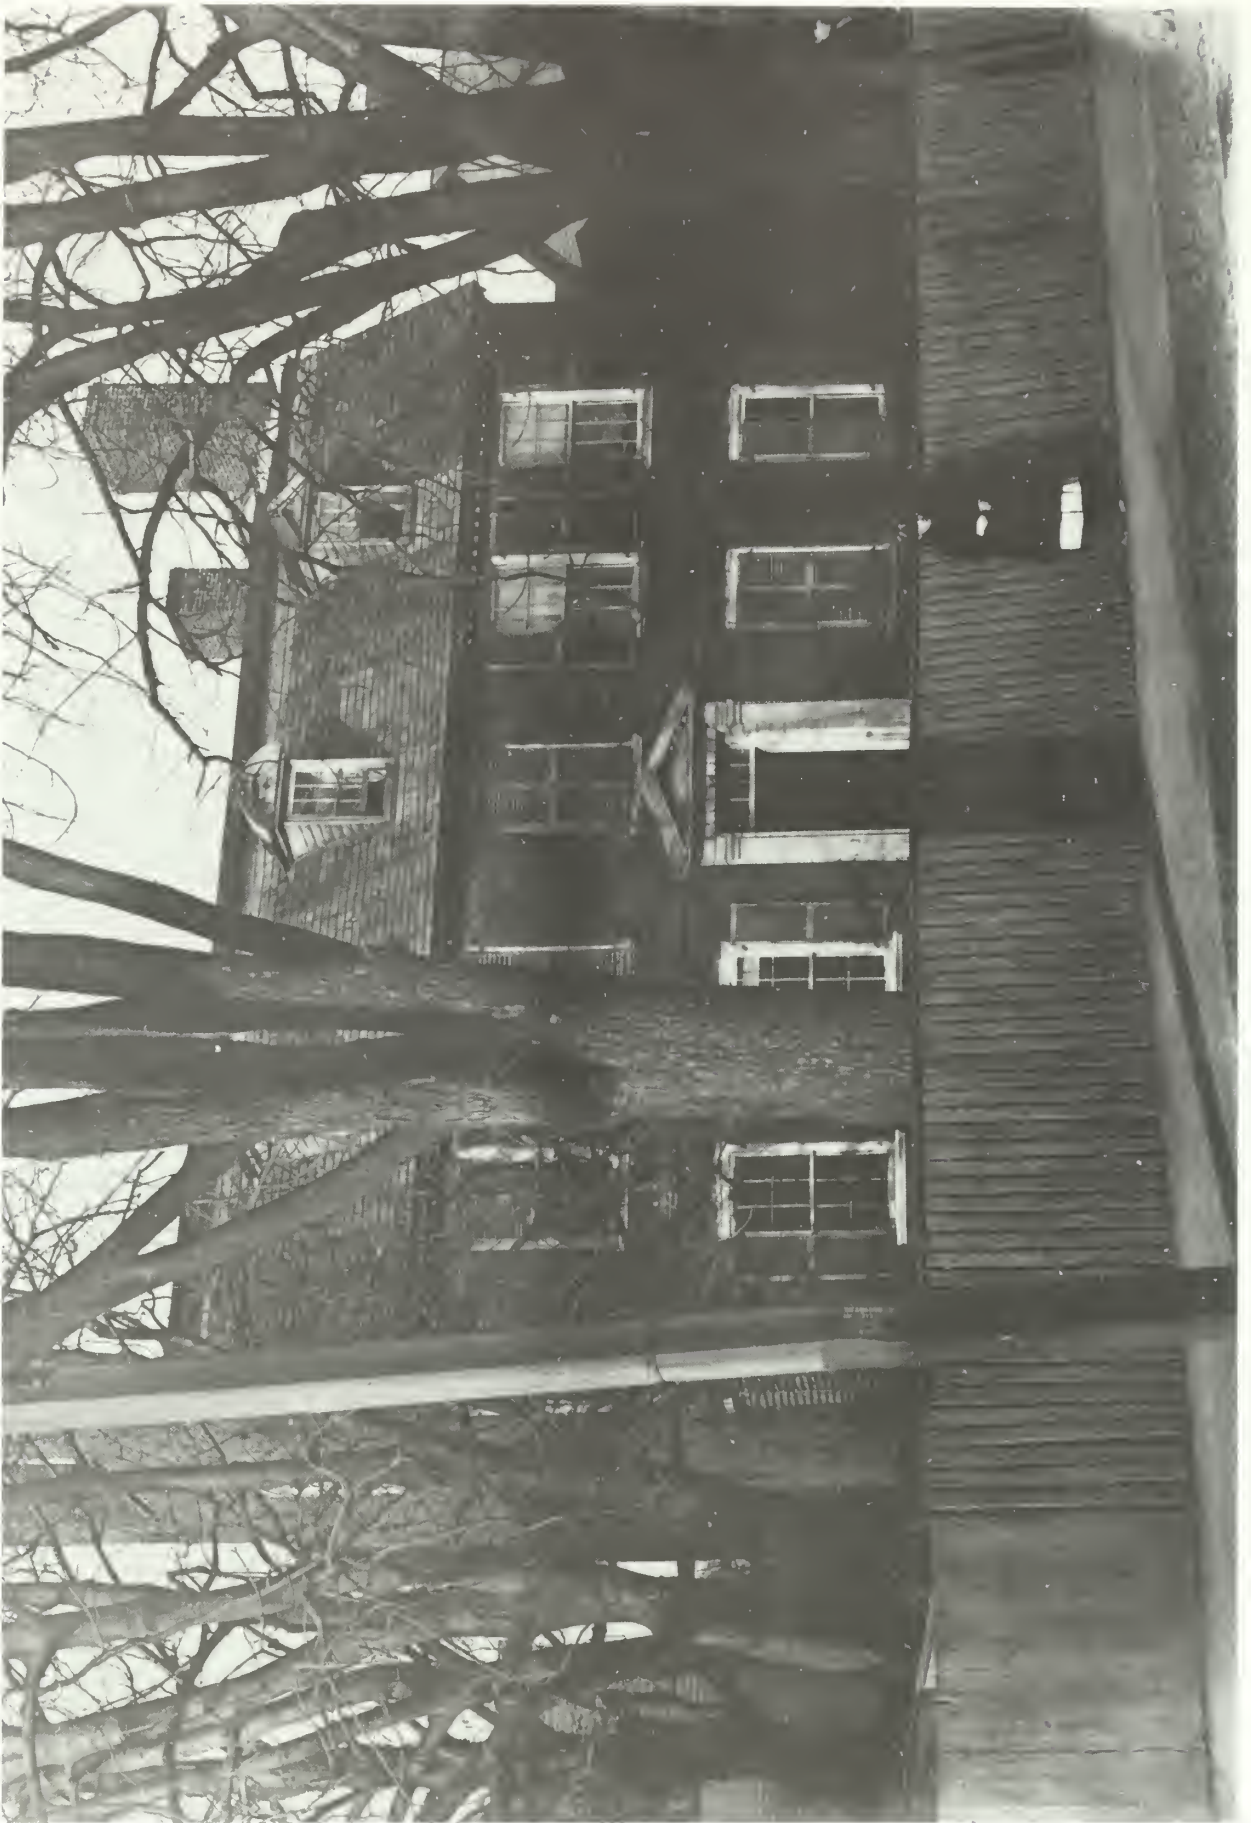
Figure 10. Derby-Prince-Ropes House and West India Goods Store, 1891.

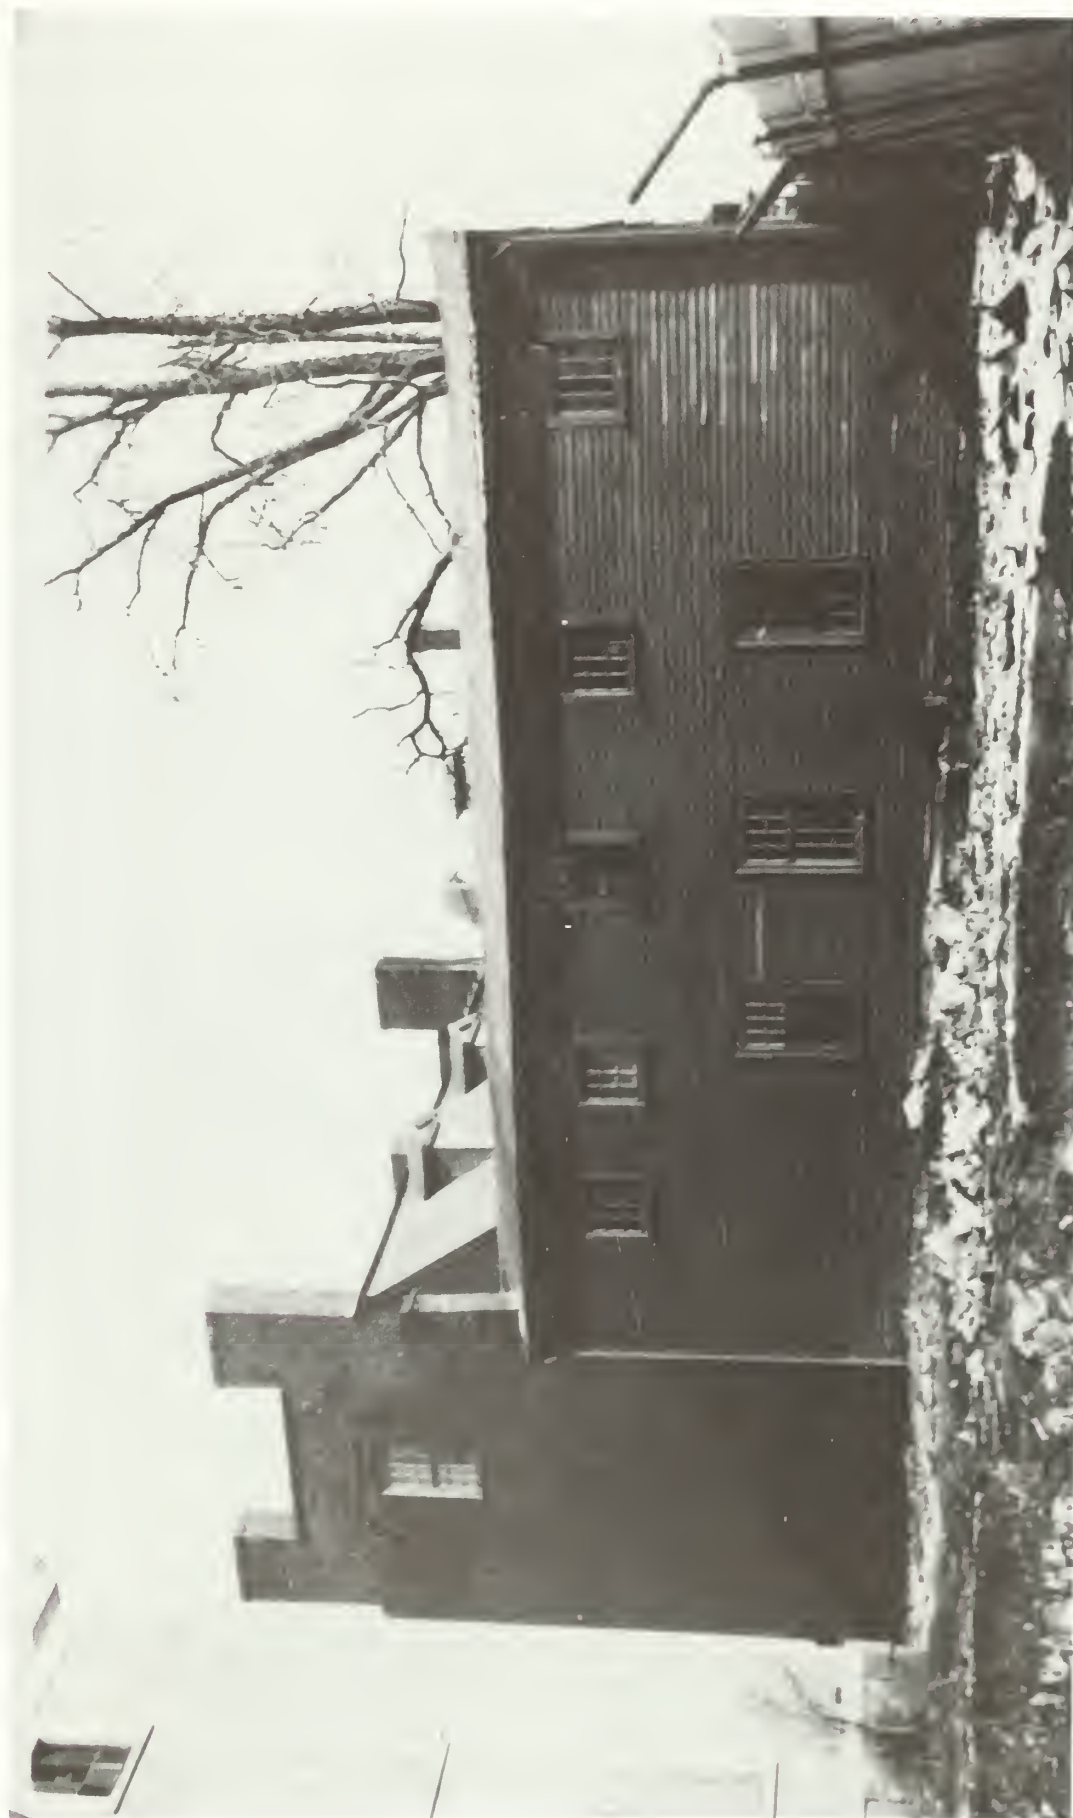
Figure 19. Hawkes House, Derby-Prince-Ropes House, and West India Goods Store, April 1938.

There is no evidence of a historic heat supply. The earliest chimney is shown in the northwest corner in the April 1938 photograph (fig. 19). A historic chimney in this position would have conflicted with the historic angled first-story northwest corner shown in the ca.-1880 and 1891 photographs (figs. 5 and 10). Neither view shows a chimney in the northwest corner. The ca. 1891-1895 and the ca. 1891-1897 photographs (figs. 11 and 12) show no chimney in the southwest corner. A chimney in this position would have conflicted with the presumed historic front doorway and stairway. The ca. 1891-1897 photograph does show a chimney approximately opposite window 1 on the west wall, in approximately the same position as a nonhistoric chimney constructed in 1947 and removed in 1965. A chimney in this position would not have served the possible historic office at the south end of the second story. The ca. 1891-1894 photograph (fig. 13) of a structure similar to the West India Goods Store shows a chimney at the right side of the street-front elevation, which corresponds to the southeast corner of the West India Goods Store. A chimney in this position could service an office on the second story, as well as the street front on the first story. Generally, most evidence of earlier chimneys was lost when the structure was moved ca. 1911-1912, and when the historic roof sheathing was replaced. Nonhistoric first-story ceiling and second-story flooring were not removed as part of this investigation. Possible historic framing may remain in place to show the position of historic chimneys. At the south end of bay A, in the second-story east wall, historic sheathing is in place from post to stud, and there was probably no historic opening here. This would allow a historic chimney in this southeast corner position.

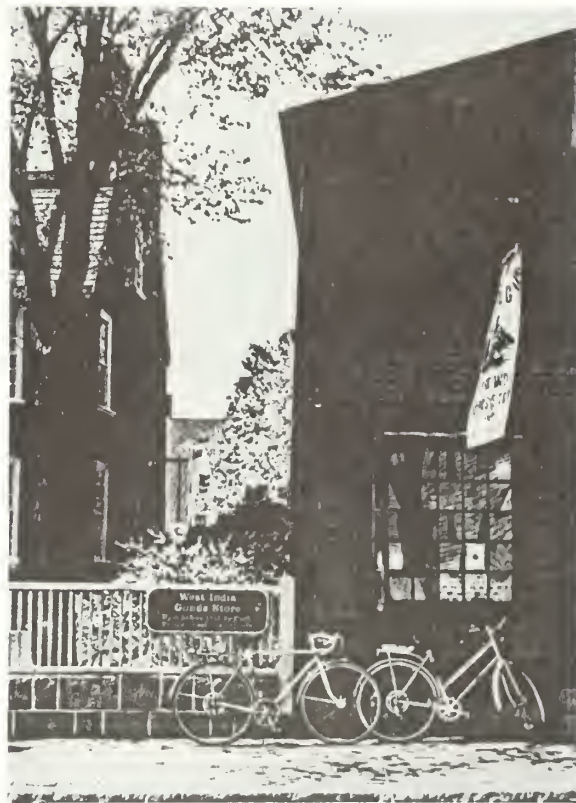
Figure 30. West India Goods Store, west end of south elevation, showing fence at southwest corner. Compare with figure 11.

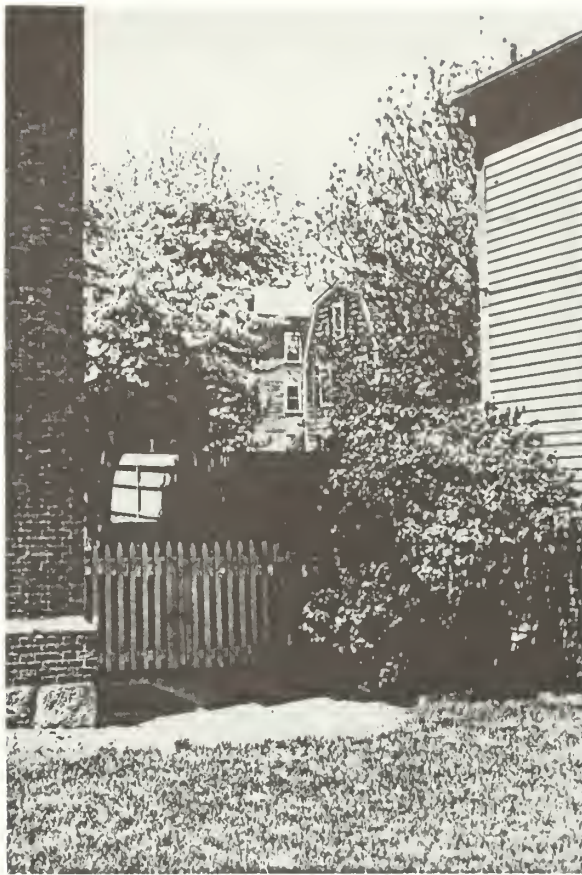
Figure 33. Corner of Derby-Prince-Ropes House, showing stairway to cellar, fence, and West India Goods Store; depicts distance between edge of stairway at grade and west wall of store.

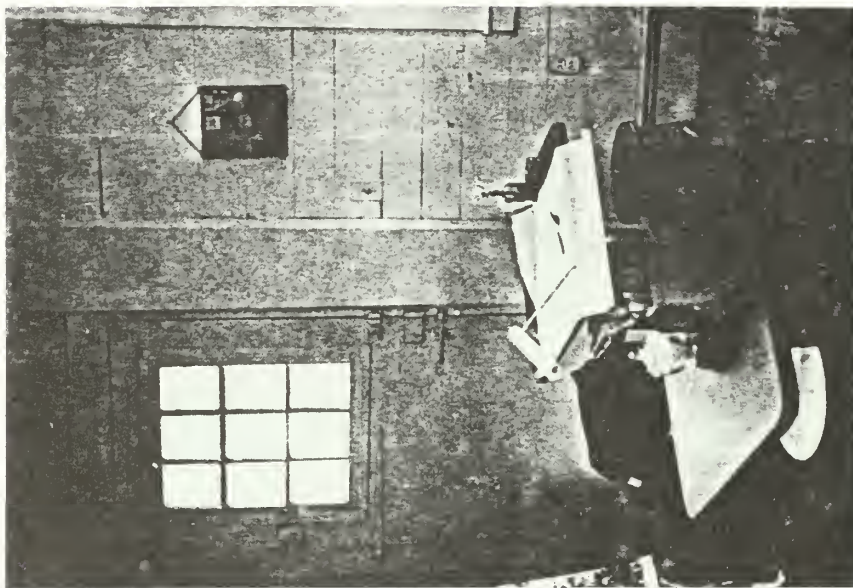
Figure 35. West India Goods Store, interior of first story, east wall, showing doorway and boxed post between bays E and D.

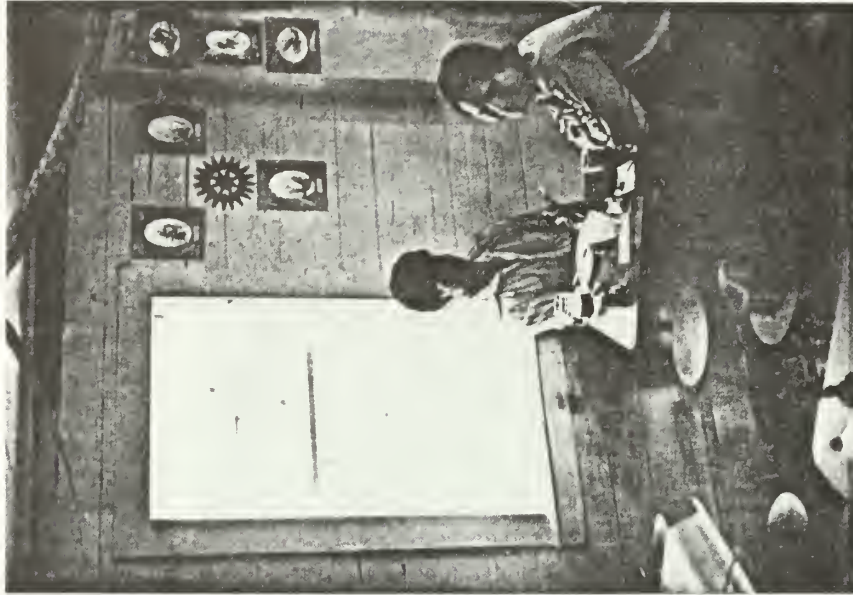
Figure 36. West India Goods Store, interior of first story, east wall, showing beaded siding, window and trim, and boxed post between bays D and C.

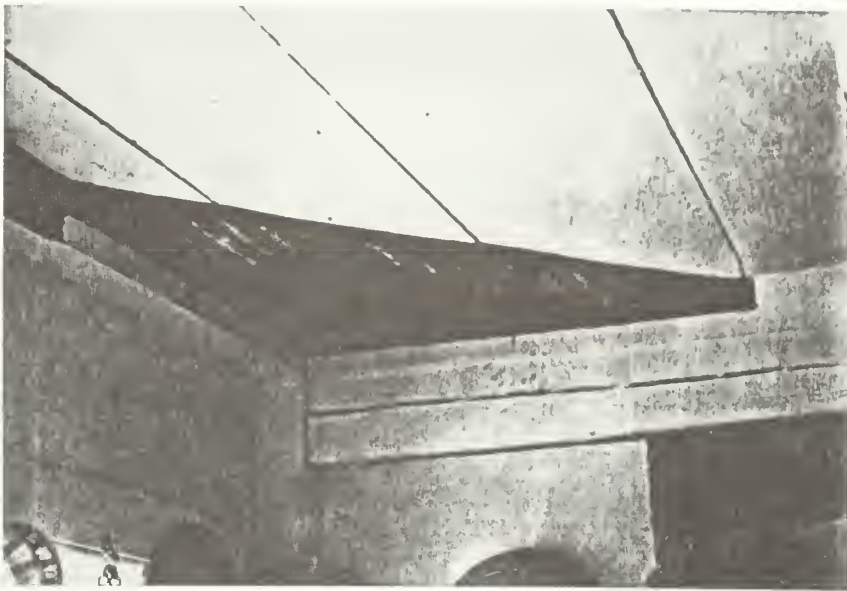
Figure 37. West India Goods Store, interior of first story, southwest corner of bay A, showing corner post, south girder, two west girts, horizontal angled brace, and wood ceiling finish.

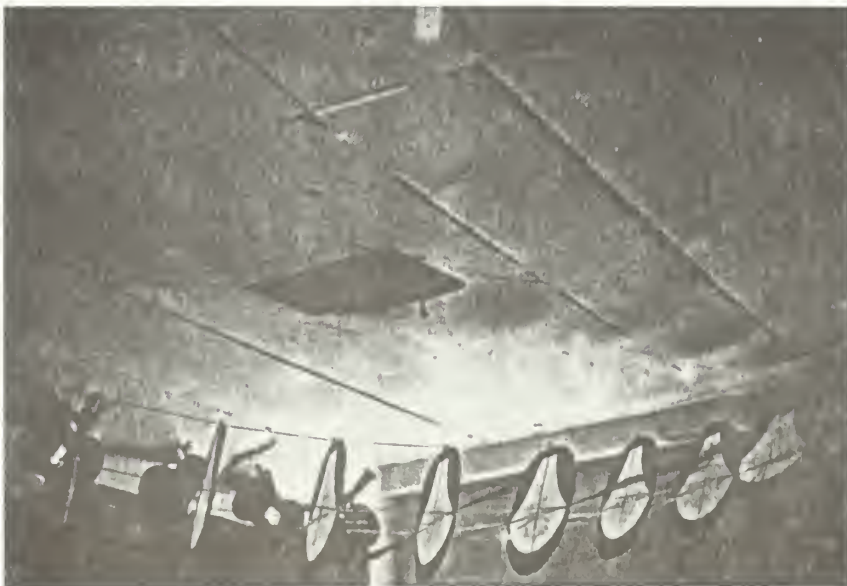
Figure 38. West India Goods Store, interior of first story, bay C, showing hole 12 by 9-1/2 inches cut in wood ceiling.

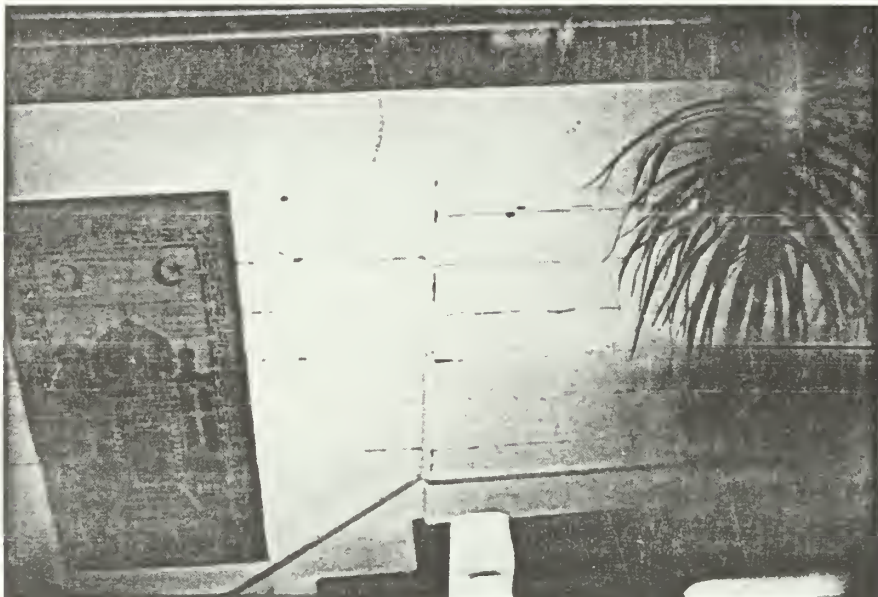
Figure 39. West India Goods Store, interior of first story, west wall of bay E, showing overlapped siding on stairway.

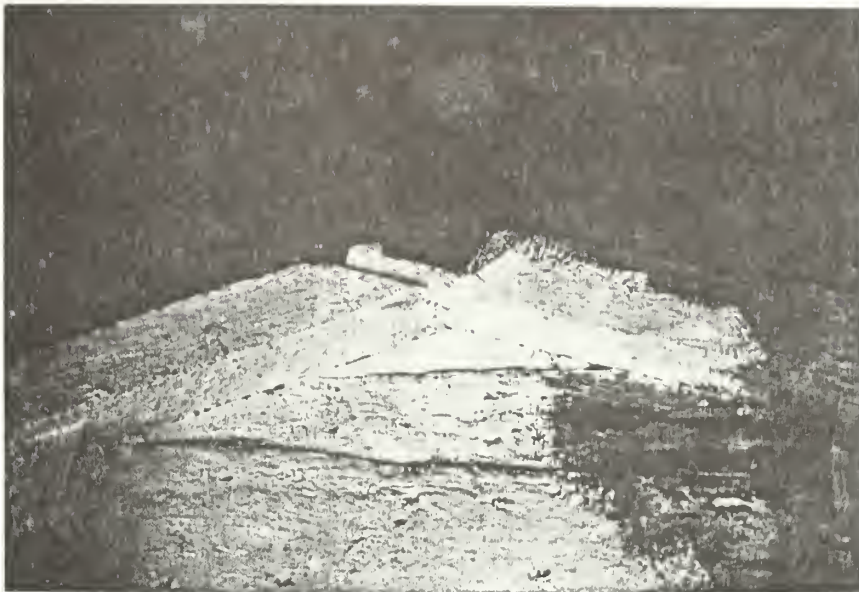
Figure 40. West India Goods Store, interior of second story, south wall, showing nonhistoric roof sheathing and purlin connection, historic rafters with mortise-and-tenon joint, historic and nonhistoric wall sheathing, and two nonhistoric queen posts.

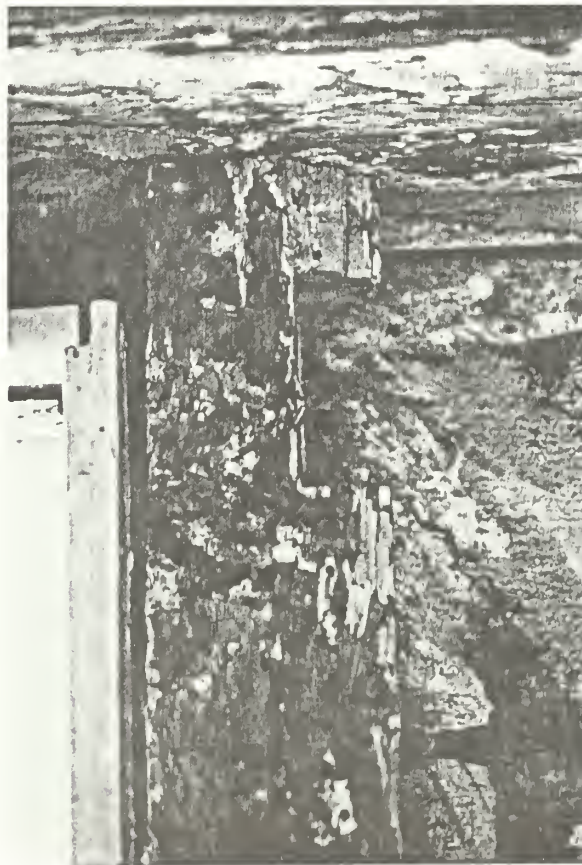
Figure 41. West India Goods Store, interior of second story, south wall, showing stud with cut to receive possible window head.

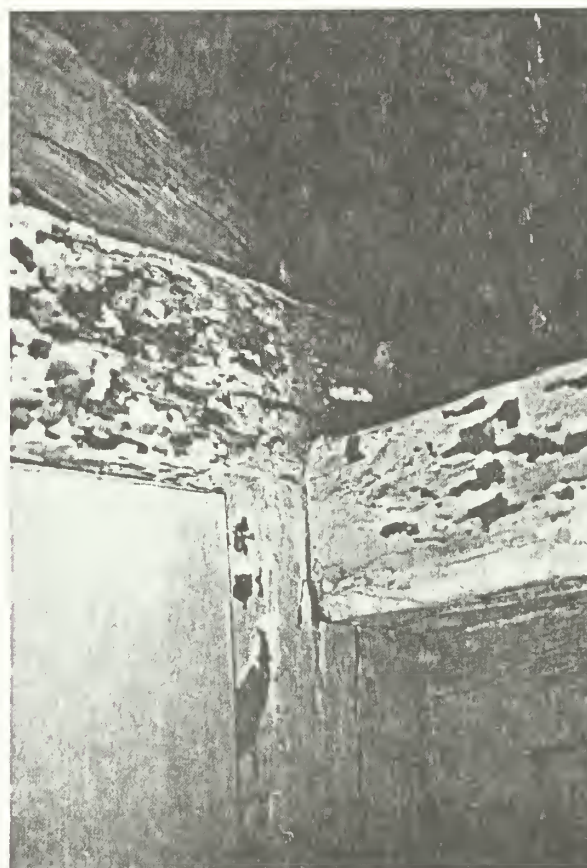
Figure 43. West India Goods Store, interior of second story, west wall looking south, showing pegged post-plate-trussed rafter connection between bays C and D.
